BHI-01384
Rev. 0

105-B Reactor Museum Feasibility Assessment (Phase II) Project

**Prepared for Bechtel Hanford, Inc.,
by MACTEC, Inc.**

June 2000

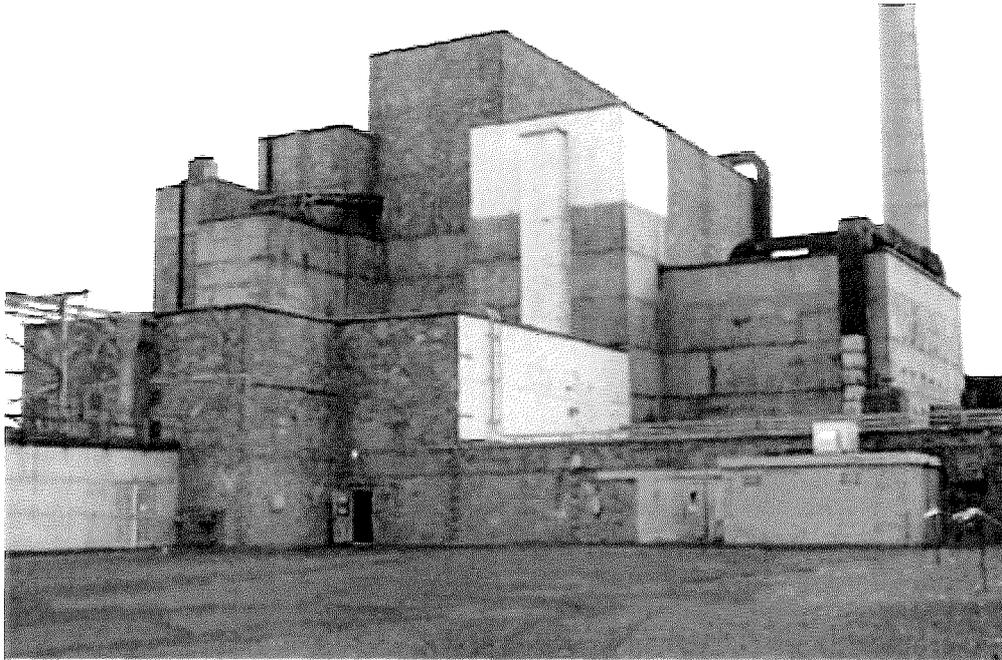
Figure 4-1. B Reactor Entrance and Current Parking Area.

The exterior areas around the building have undergone a considerable number of decommissioning activities over the past several years. As surrounding structures have been removed, the perimeter landscape has been replaced with river rock and crushed-rock material. The primary purpose of these materials is to provide dust control. A small area of asphalt material near the tool/storage area (at the northern entrance) serves as a loading area. The asphalt is very old and has broken apart in many locations. Currently this is the only paved parking area for the building. The parking capacity of the paved area is estimated at about 20 standard-sized automobiles, configured in a conventional parking arrangement. Figure 4-1 shows the front entrance to the B Reactor and the parking area located on the north side of the B Reactor. Two entry doors that provide access to the tour route in B Reactor are depicted in Figure 4-1. The double-door entry on the right side is considered to be the main entrance to be used by tour groups. A second entry door (open door in Figure 4-1) is shown in Figure 4-2. The door steps down to a small concrete walkway, which extends out to the north a short distance.

The original ductwork on the exterior of the building appears to be rusted (see Figure 4-1 and front cover). Although not observed closely from the roof, the structural supports for the ductwork also appear to be rusted. The supports will eventually rust through and the ductwork would fall to the roof. Although the impact force is unlikely to cause any structural damage, falling ductwork would almost certainly damage the roofing and cause additional roof leaks. A more likely condition would be that a wind storm would cause the ductwork to fail, and pieces of the ductwork would become an airborne flying hazard. Although it would not travel far, the flying debris would be a hazard to someone on the ground in the vicinity of the building.

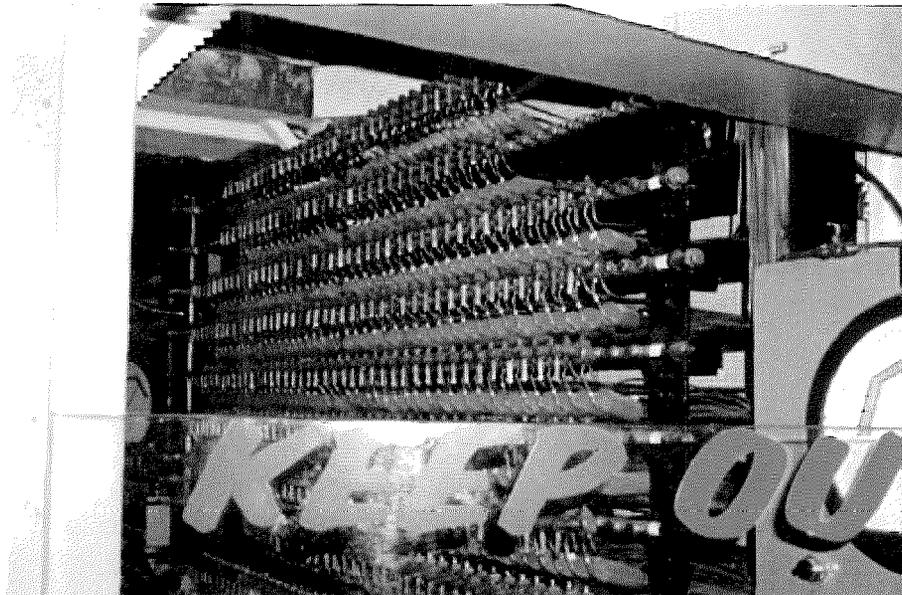
Figure 4-6. Barrier in Control Room.

behind the display panel in the southwest portion of the work area. A caged ladder just visible in the upper left of the picture can be reached and climbed. In addition, there is easy access to a radiological buffer area (RBA) that is presently only roped off. Doors to rooms entered from the main corridor that are not part of the primary tour route are unlocked or left open.

To mitigate the hazards and correct deficiencies associated with public access control, areas behind the control panels in the control room and areas behind the display panels in the front-face work area shall be properly barricaded to prevent passage while maintaining visual access. The barricade to be erected in the area of the display panel in the southwest portion of the work area will also prevent access to the caged ladder. The barrier will allow access through the sliding steel door (visible on the right side of Figure 4-7), which will be permanently secured open for the new egress pathway. Barriers shall be arranged to completely block access to the restricted areas by the public but will allow access by S&M personnel. Each barrier will be securely attached to adjoining building structures. Plexiglass panels will be incorporated where viewing of components is desired. Doors to rooms entered from the main corridor shall be locked. New latchsets/locksets shall be installed where the existing door hardware is damaged or inadequate. Where viewing of a room is desired, plexiglass panels shall be installed in the doorways.

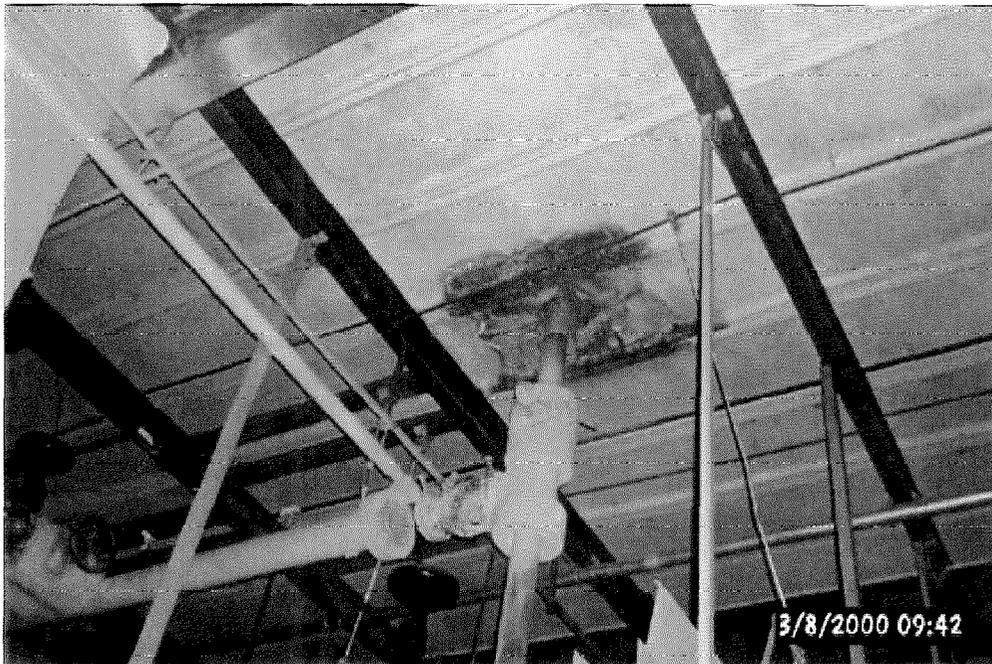
Figure 4-8. Typical Roof Panels/Stains (Not in Primary Tour Route).

On the basis of information reported in reference material item engineering change notice (ECN) 600276 (WHC 1994b), the total allowable roof loading is 50 psf. The total load is assumed to include both dead and snow loads. While this is probably adequate for most roof areas, there are several areas where snow drifts could occur. In these areas, the drift snow loads imposed by code requirements exceed 100 psf. Even in an undamaged condition in those areas where snow drifts can occur, the roof does not meet current code requirements. This also does not take into account any de-rating of the existing structure that may be applied in consideration of corrosion or aging of the structural steel.

Repairs have been made to individual pre-cast roof panels that were showing signs of excessive deflection and corrosion. The repair included installing Unistrut members to support the damaged panel. The design for the repair is shown in reference material item ECN 600275 (WHC 1994a).

Total replacement of the pre-cast concrete roof panels is shown in reference material item ECN 600276 (WHC 1994b). The replacement has not been implemented. The design shows a light-gauge metal roof attached to the roof support beams. The new roof would prevent further roof leaks. Total replacement would be a complete fix rather than the isolated “Band-Aid” type roofing repairs that have been previously made. There would be no need for additional Unistrut members to support damaged panels. Removing the dead load of the heavier concrete panels increases the capacity of the roof system. The total structure weight of the roof would be decreased, so seismic roof forces also would be decreased.

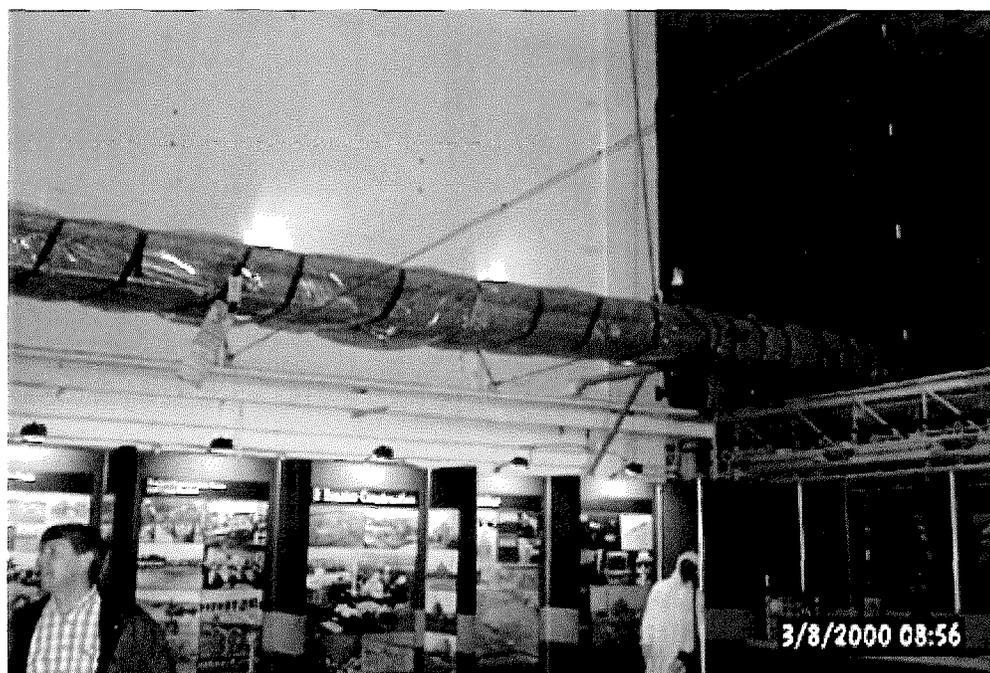
Figure 4-9. Overhead Bundle Rack of Process Tubes.

There is a bundle rack of process tubes (Figure 4-9) in the front-face work area suspended over areas where tour guests may walk. The strength of the supporting rack and crane cannot be verified and appears to be a potential falling hazard. The canvas drop shield in front of the reactor core (no picture available) is also suspended near areas where tour guests may walk. It is extremely heavy and is also a potential falling hazard. The support mechanism for the drop shield is as old as the building and is considered to be suspect. Roof leaks also were observed in the front-face work area.

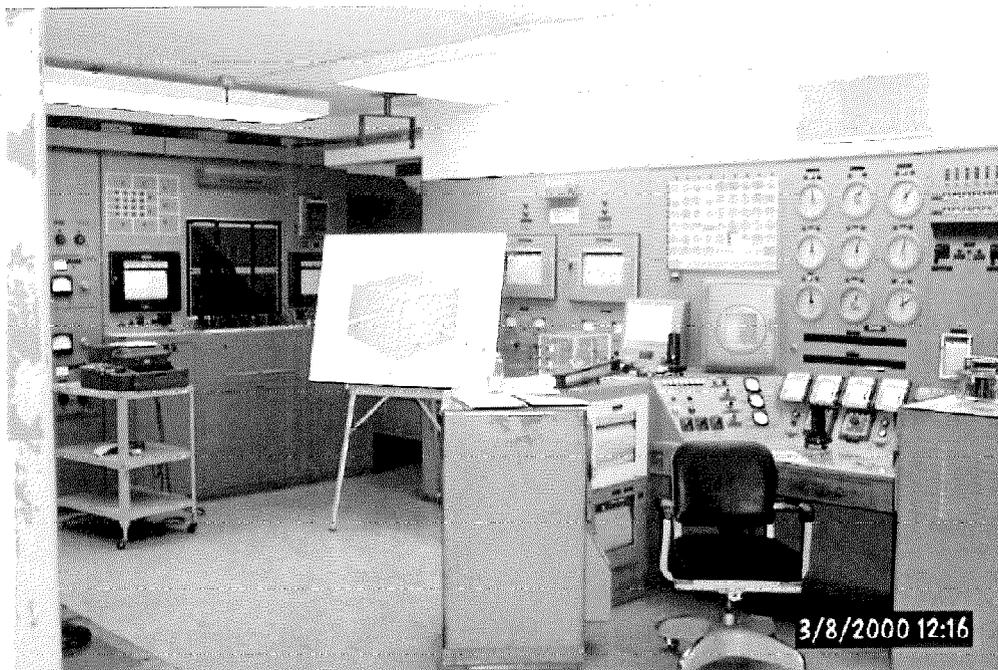
Figure 4-10. Control Room.

It can be assumed that the majority of the paint throughout the facility contains lead. There are a number of areas, including in the control room (see Figure 4-10), where the paint is chipped and peeling. Following the cleaning, any area observed to have flaking or peeling paint shall be painted over with a high-quality, lead-free paint. Subsequent periodic inspections of the paint throughout the facility should be performed to maintain the integrity of the paint in the facility and preclude lead exposures.
