BHI-01282
Rev. 0

Hanford B Reactor Building Hazard Assessment Report

Submitted by: Bechtel Hanford, Inc.

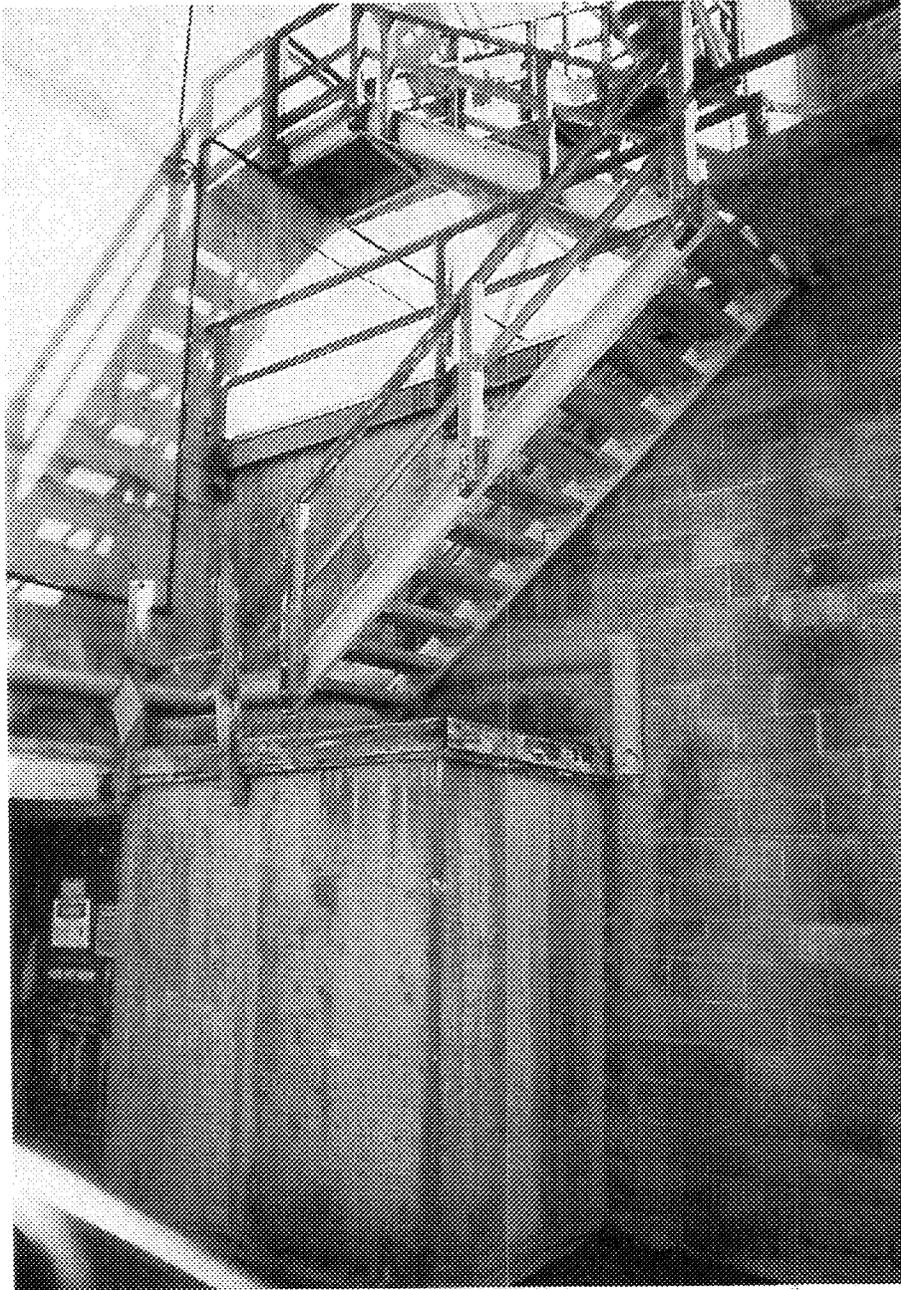
- Exterior stairway up south side of reactor: The wooden stairway (with concrete treads) up the south side of the reactor building has not been maintained and appears to be in poor condition. The wood has weathered, nails/bolts appear to be loose, and treads appear to have major cracks. (*Photograph 1*)
- Broken conduit with exposed electrical conductors. (*Photograph 2*)
- Covers (doors) missing from transformers.
- Peeling paint on both metal and wood surfaces may contain lead.
- Building penetrations need to be sealed to prevent animal intrusion.
- The wood roof over the tool/storage area on the north side shows signs of water damage.
- Wood covers over the stack plenum openings are weathered. (*Photograph 3*)

Photograph 1. Wood Stairway on South Side of the Reactor Building.

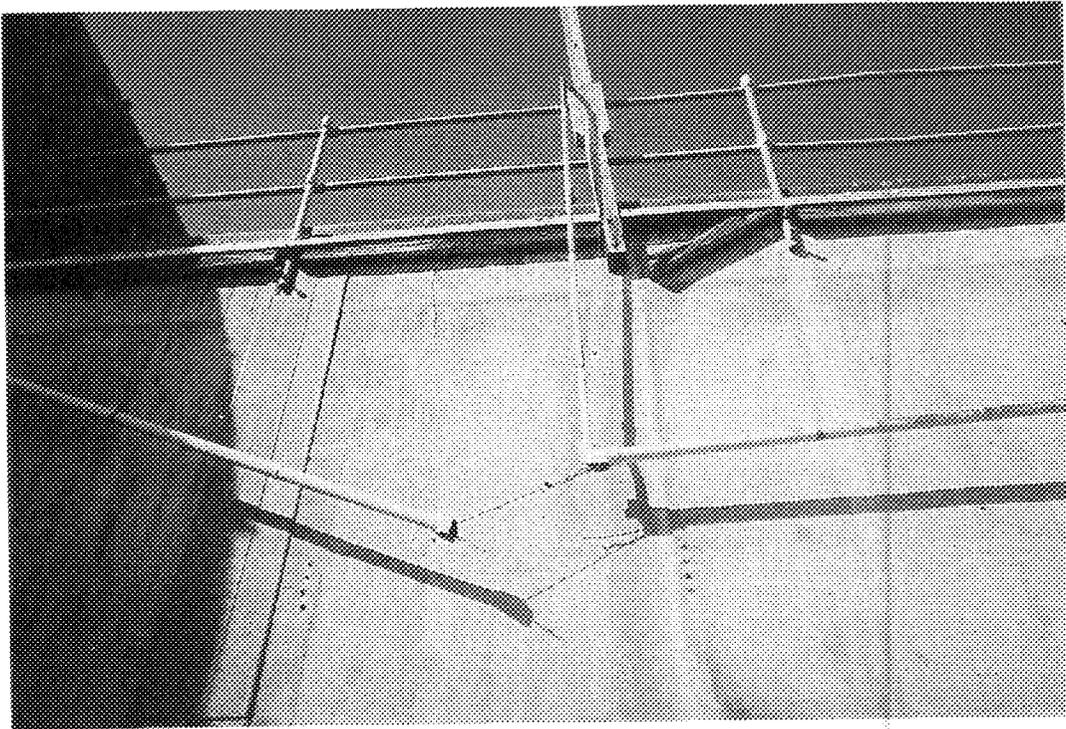
Photograph 2. Broken Conduit with Exposed Electrical Conductors.

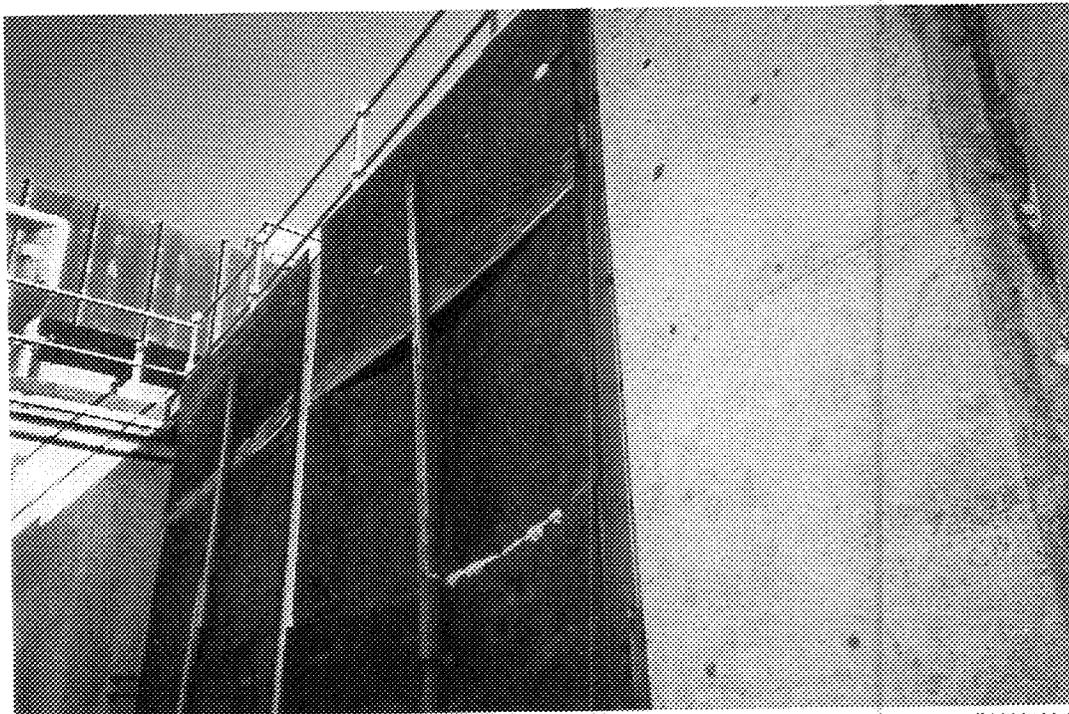
Photograph 3. Wood Covers Over the Stack Plenum Openings.

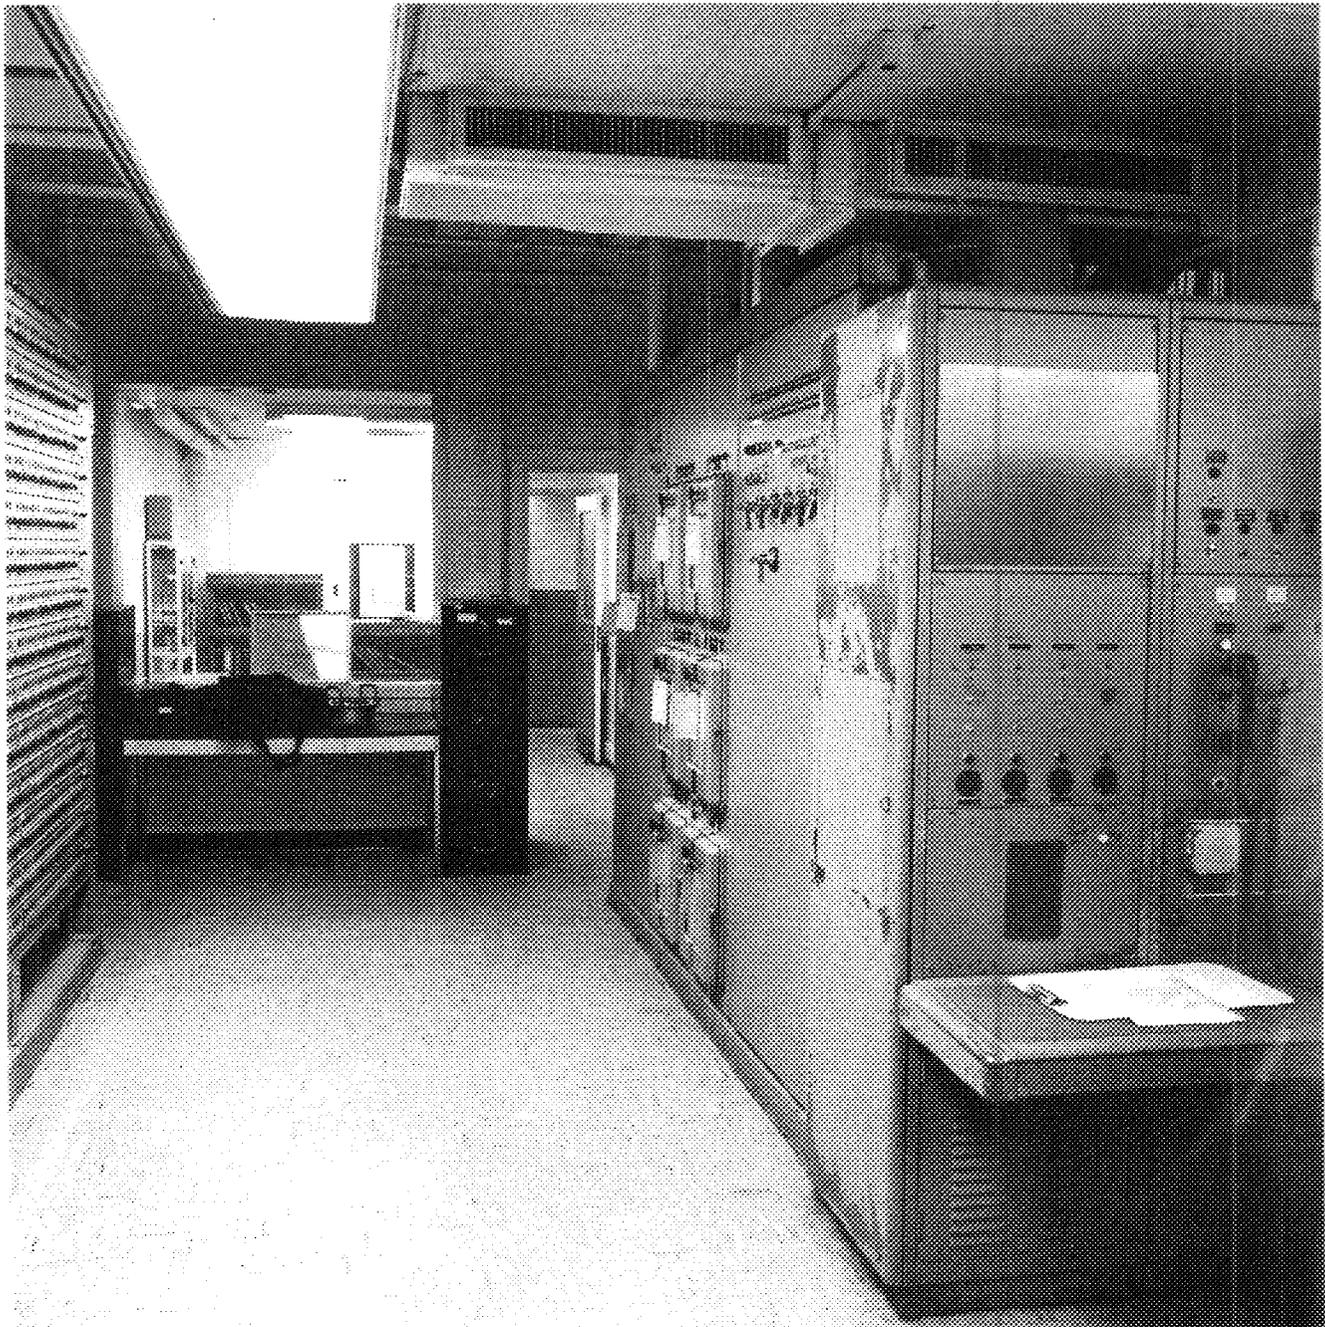
Photograph 4. Peeling Paint in Control Room.

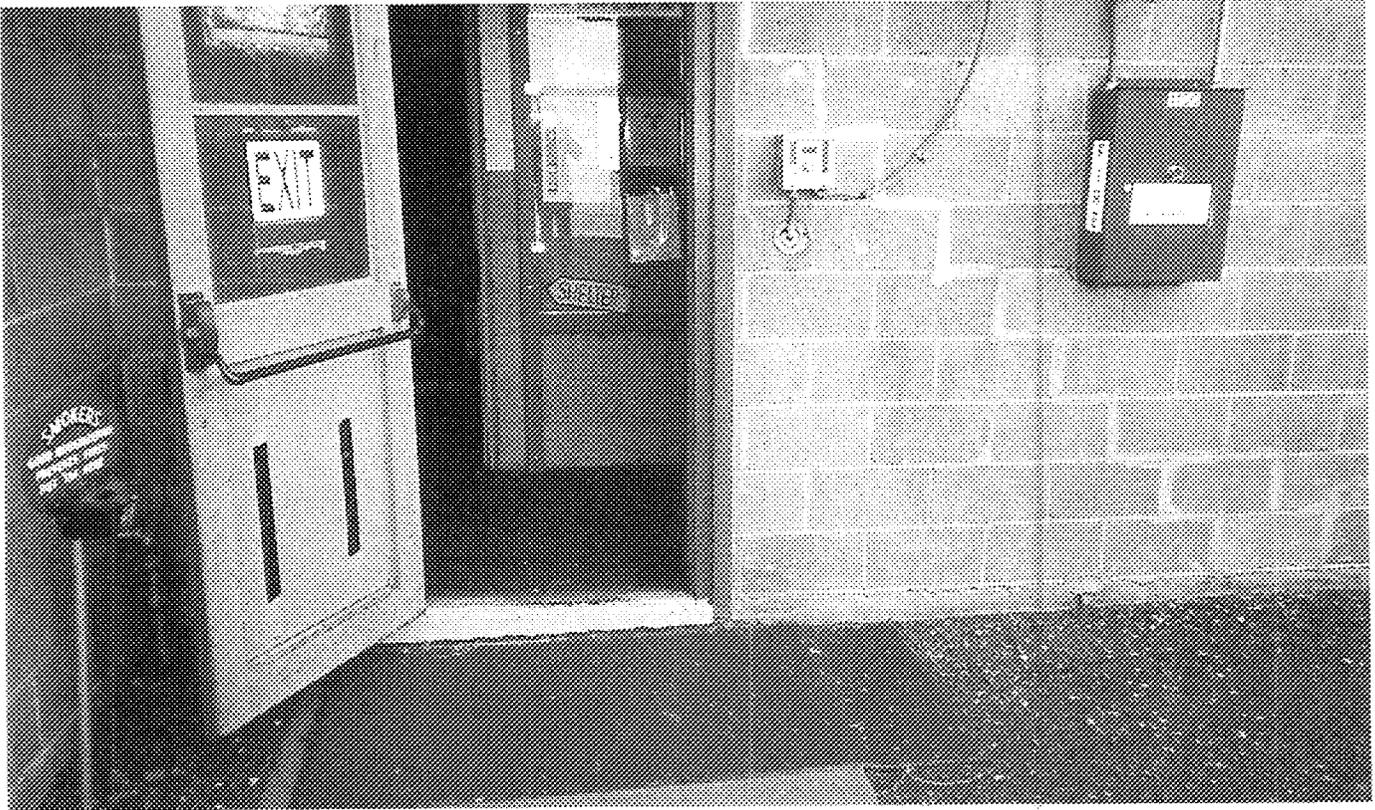
Photograph 5. Tripping Hazard Through Doorway.

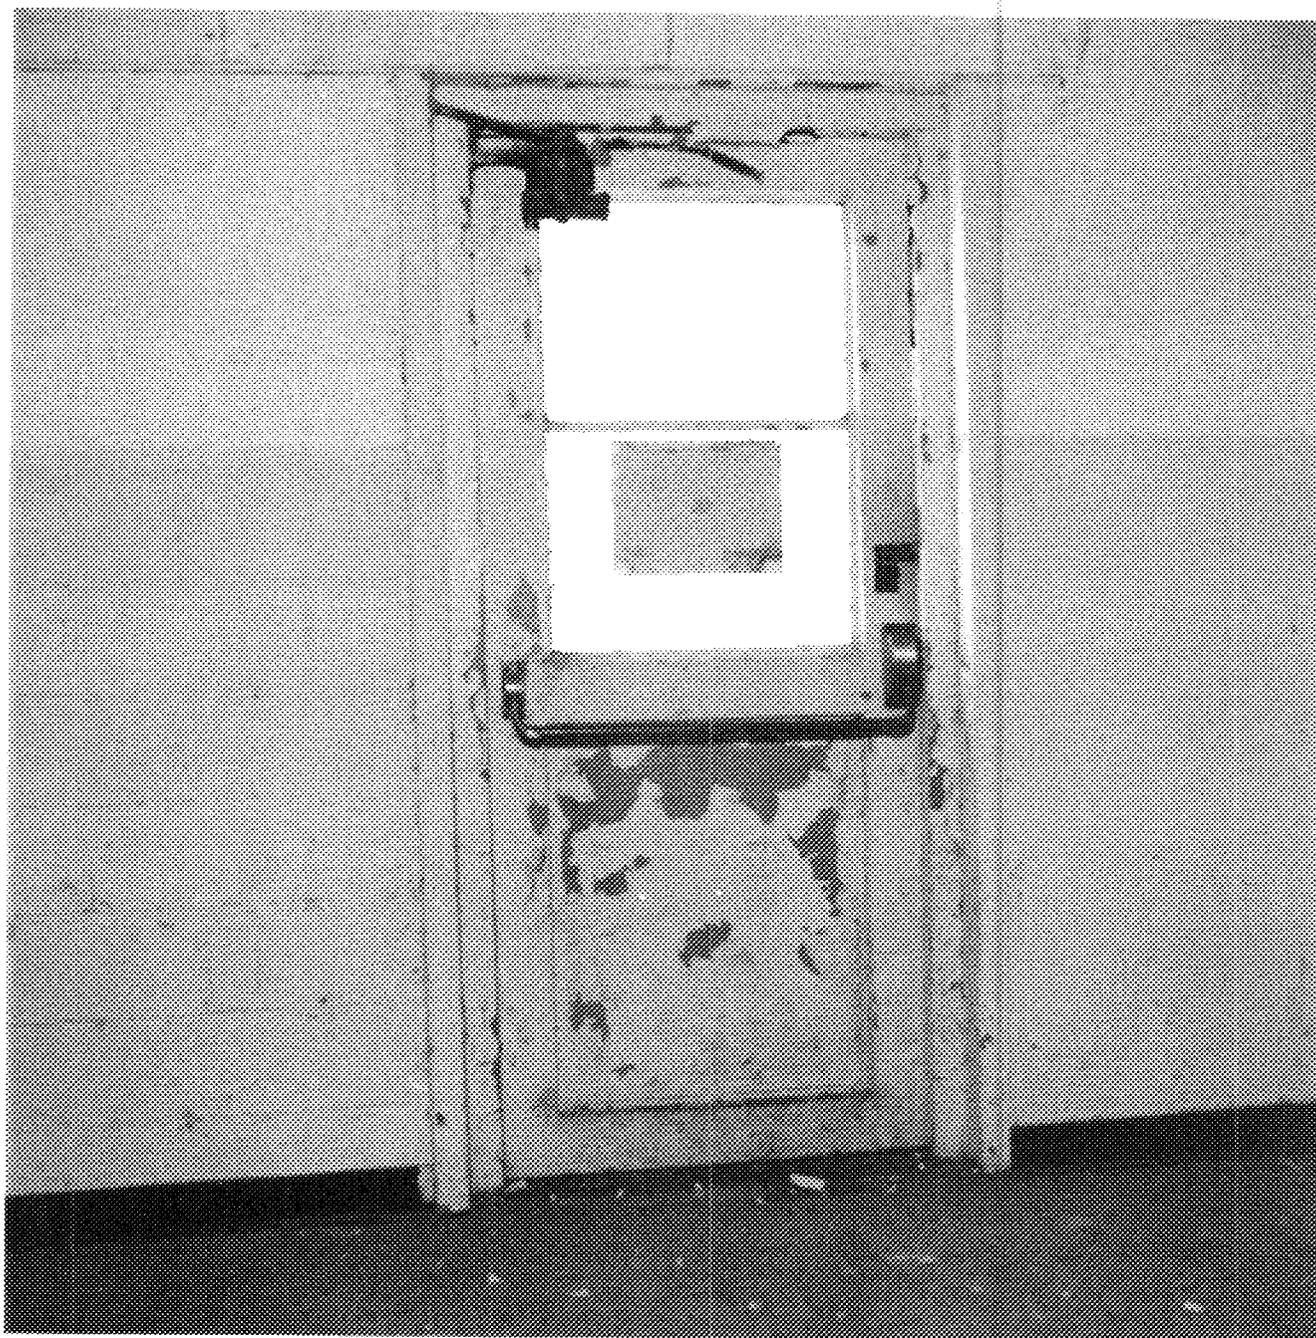
Photograph 6. Peeling Paint in the Lunch Room.

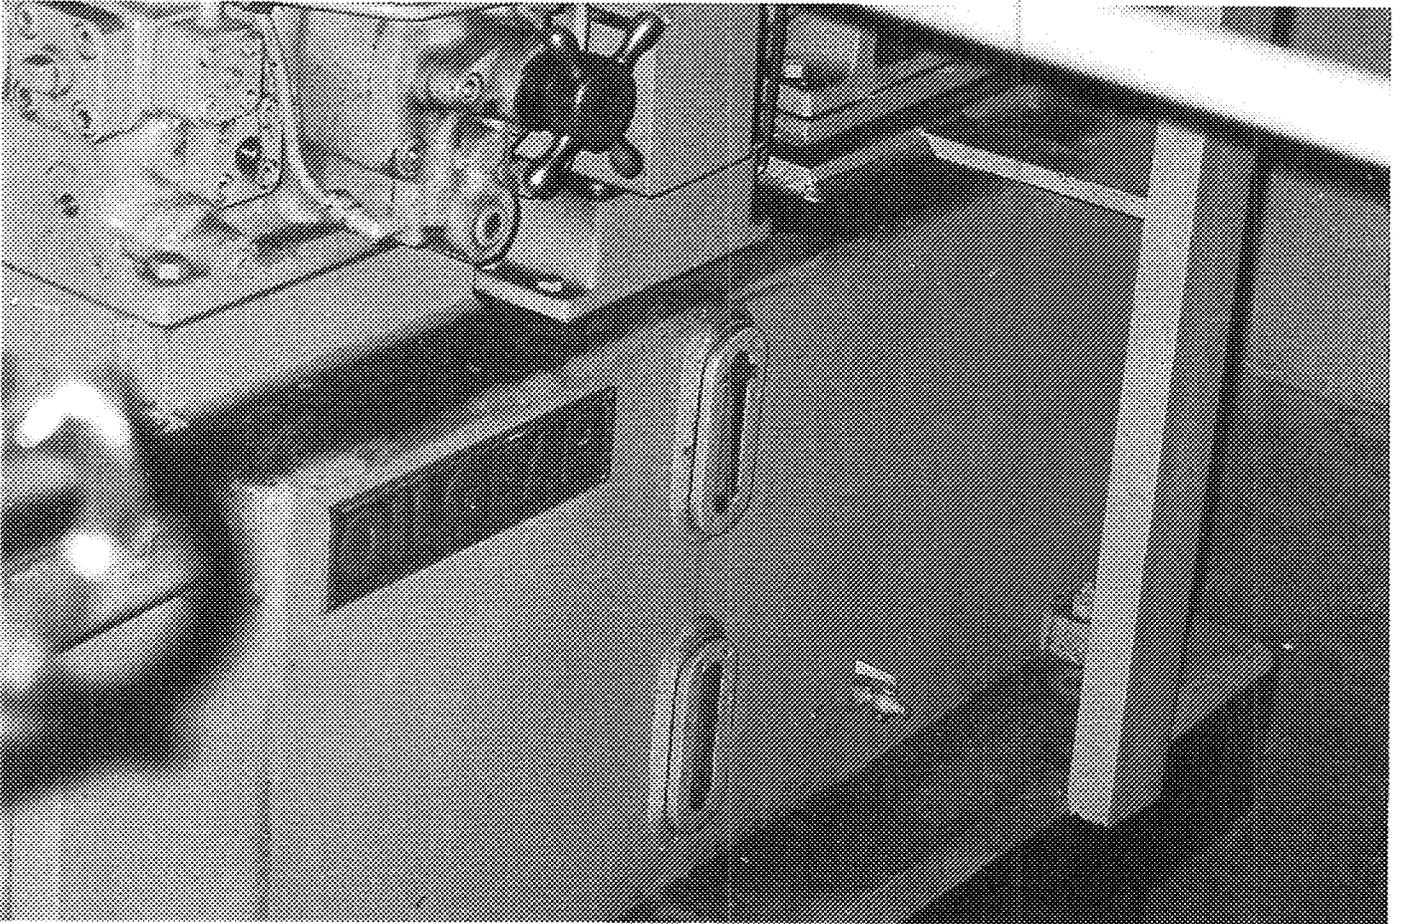
Photograph 7. Leaking Oil on Equipment.

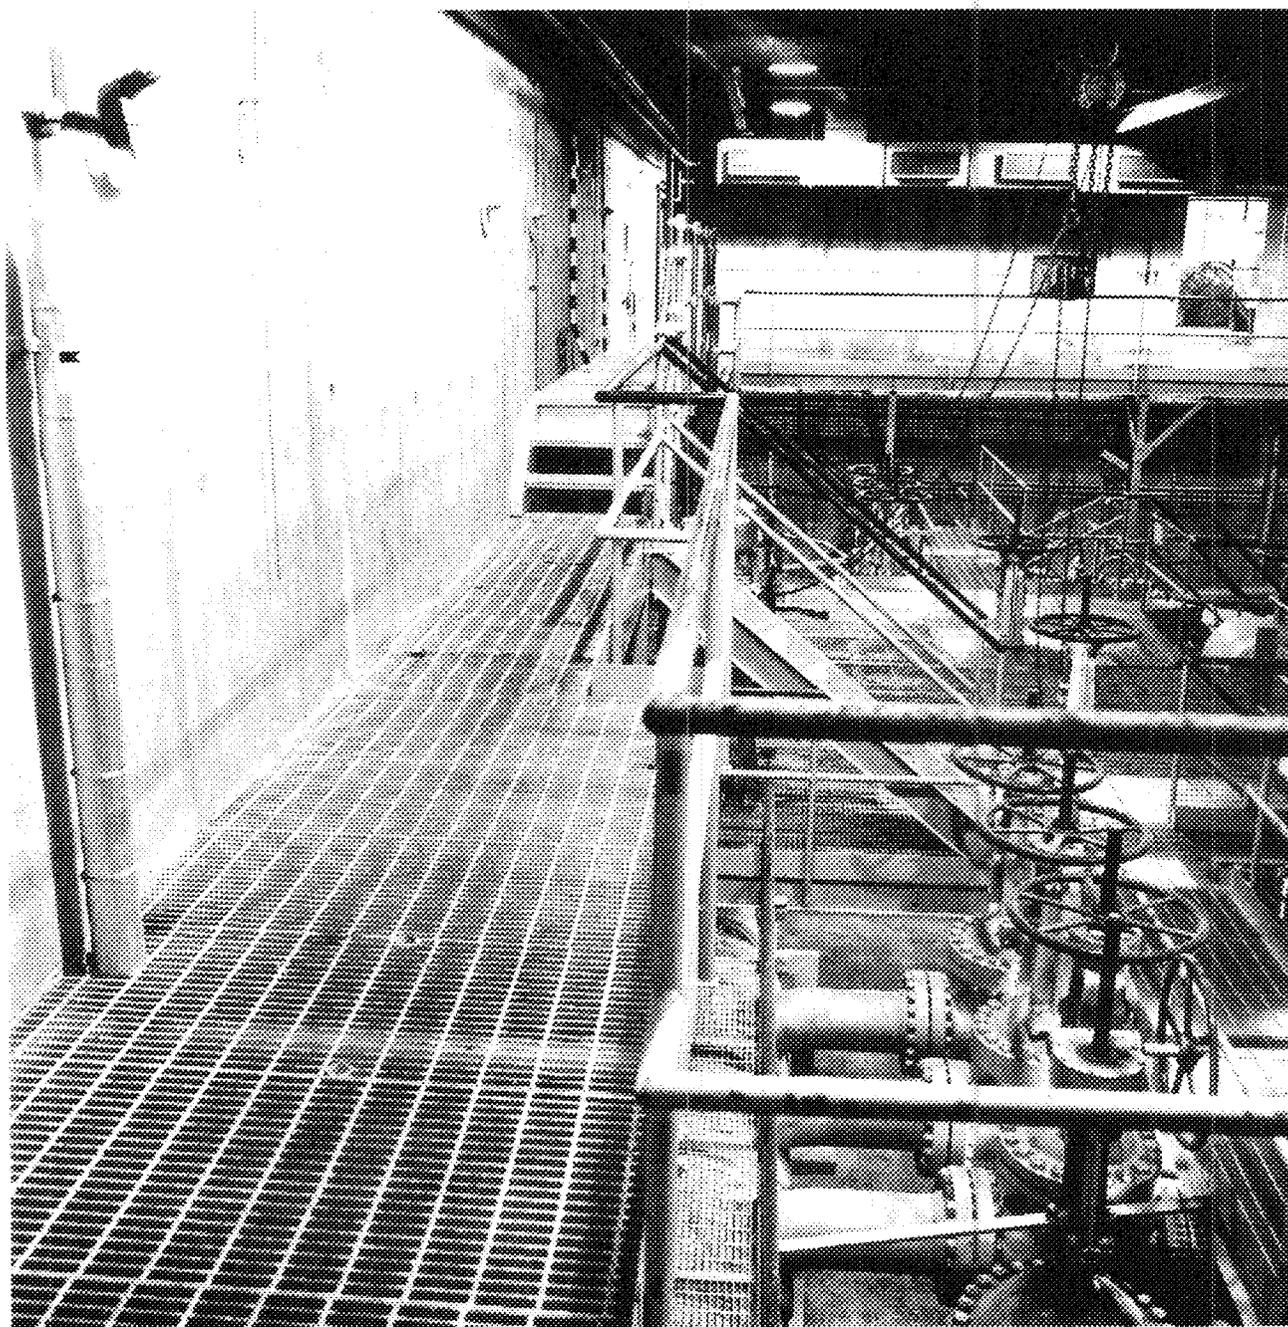
- Lunch room: Old fluorescent fixtures, possible PCBs.
- Room No. 5 (electrical equipment): Semi-volatile organics.
- Room No. 5: Batteries for the emergency lights.
- Fan rooms: Emergency lights and batteries.
- No. 8 fan supply room: Calcium chloride or similar desiccant in moisture absorbers on air lines.
- Fan room: Oil on casings of fan motors. (*Photograph 7*)
- Fan room: Dehydrator has oil in it and is dripping on the floor.
- Room No. 5 (electrical equipment): Oil in the seismometer.
- No. 8 fan supply room: Oil in air line accumulators.
- No. 9 fan cell: Oil in moisture separator.
- Basin viewing room: Oil separators on air line.
- Fan Rooms: Oil in motors and fans, hydraulic pistons on dampers, and hydraulic fluid in Kwik Srak fork truck.
- Supply fan room: No lighting.
- Grated walkways could create a tripping hazard to individuals with heeled footwear. (*Photograph 8*)

Photograph 8. Grated Walkways.

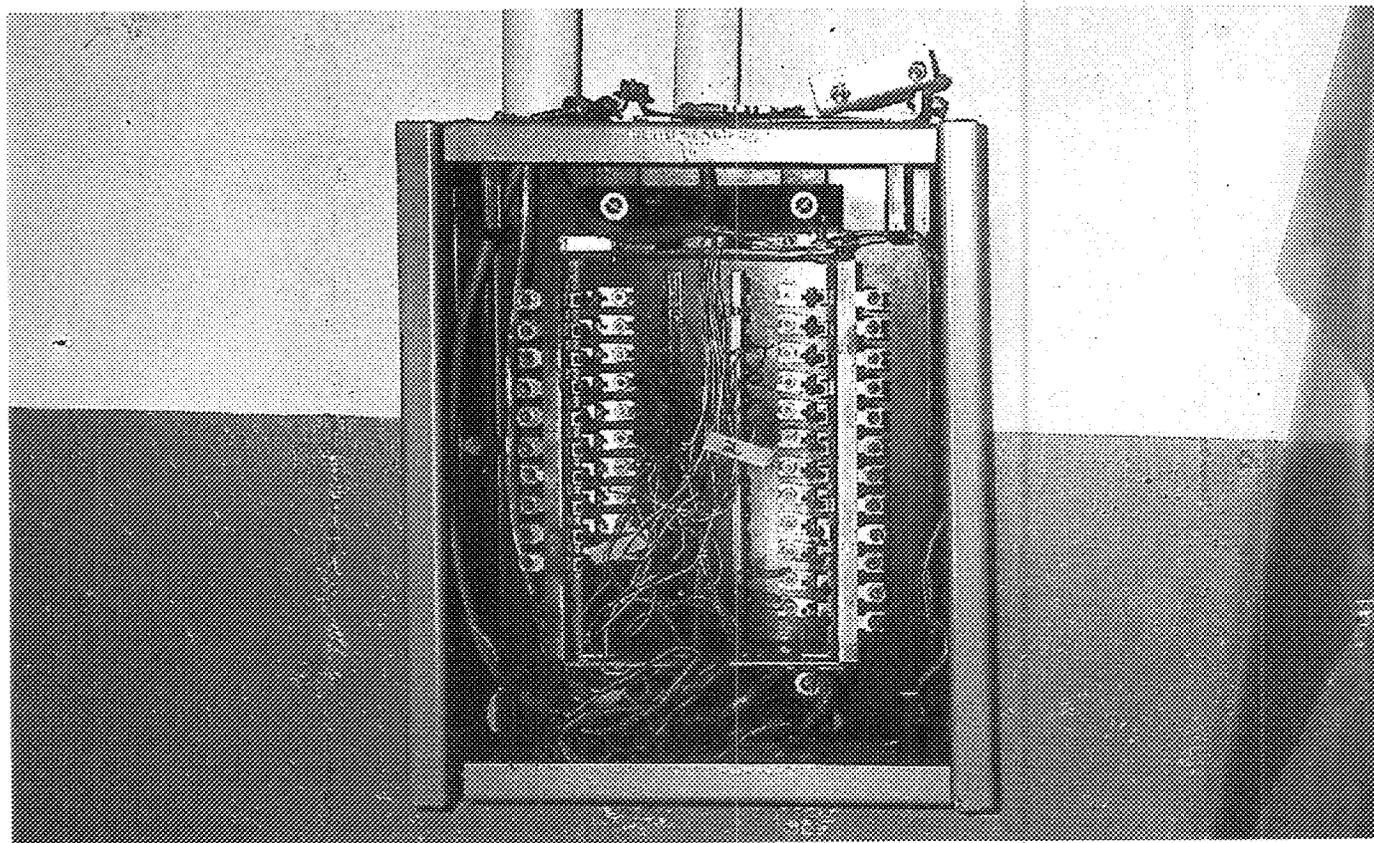
Photograph 9. Missing Electrical Covers.

- Electric equipment room: Missing covers on the wireway and gutters. Locate energized lines and isolate, label, or put barriers in place. Exposed wiring on the “C” platform should have “DO NOT TOUCH” signs on barriers. (*Photograph 9*)
- Electrical equipment room No. 35: Incandescent light fixtures missing lamps and globes. Fluorescent lighting fixtures need repair.
- Electrical switch gear room (Room 25): Wiring hanging from the wireway and sliding access doors are not secured from opening and may contain energized circuits.

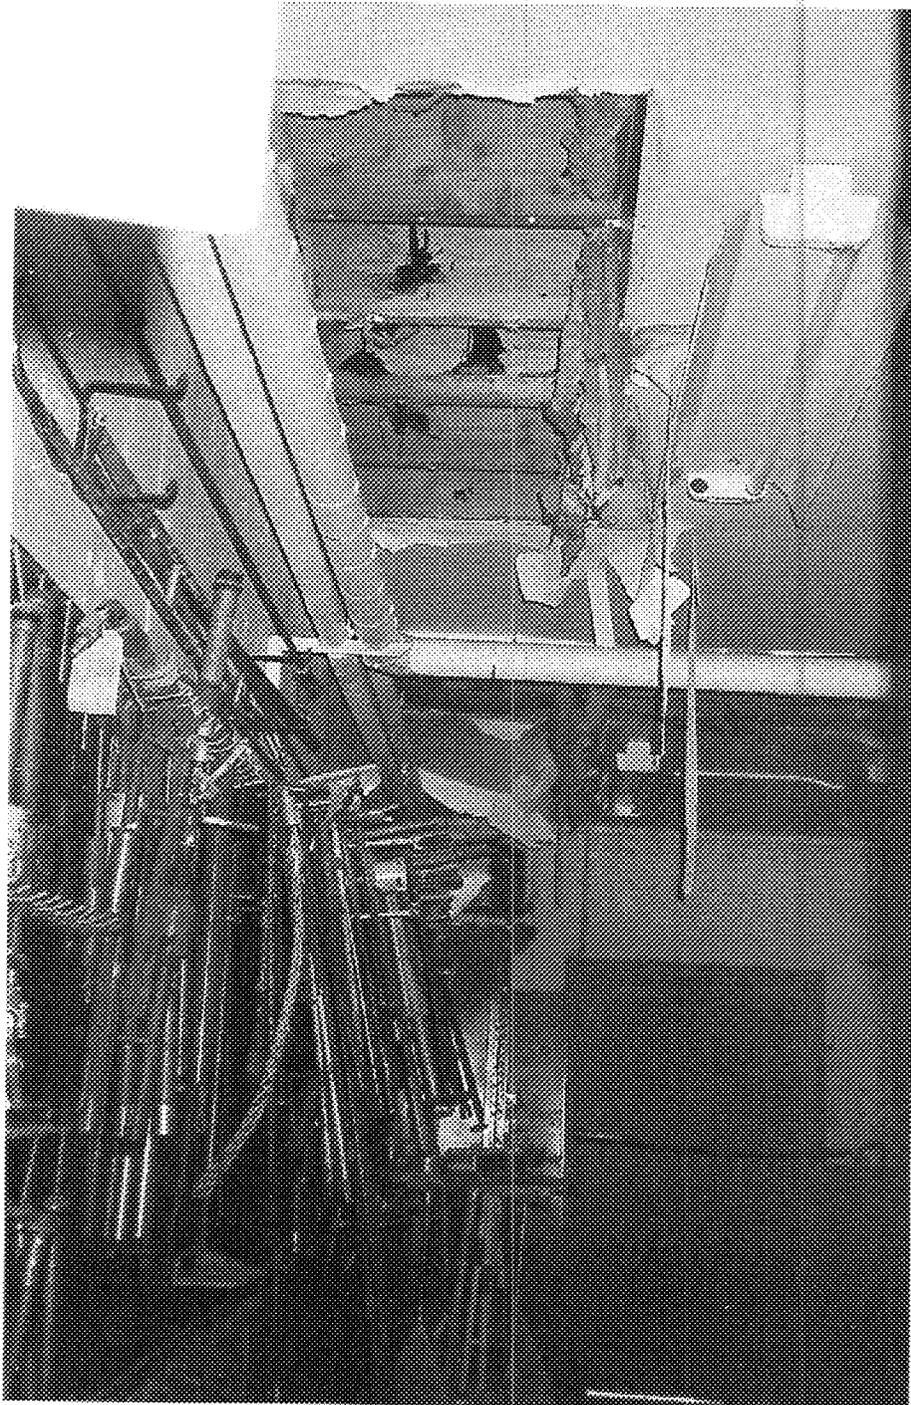
- Tool/storage area : The wood roof that extends outward on the north side of the reactor shows signs of water damage. The water-damaged wood will continue to deteriorate, creating an unsafe condition in the future.

Photograph 10. Conditions in the Tool Storage Room.

The wooden roof over the Tool/Storage Area that extends outward on the north side of the reactor shows signs of water damage. The water-damaged wood could continue to deteriorate creating an unsafe condition in the near future.

- Tool/storage area: It is recommended that no tours be allowed in this area until proper repairs are made and that the current condition is monitored/inspected periodically (every six months, after heavy rains, or when there is snow build-up). (*Photograph 10*)

It is recommended that no tours are allowed in this area until proper repairs are made and that the current condition is monitored/inspected periodically (every six months, after heavy rains, or when there is snow build-up).
