BHI-01384
Rev. 0

105-B Reactor Museum Feasibility Assessment (Phase II) Project

**Prepared for Bechtel Hanford, Inc.,
by MACTEC, Inc.**

June 2000

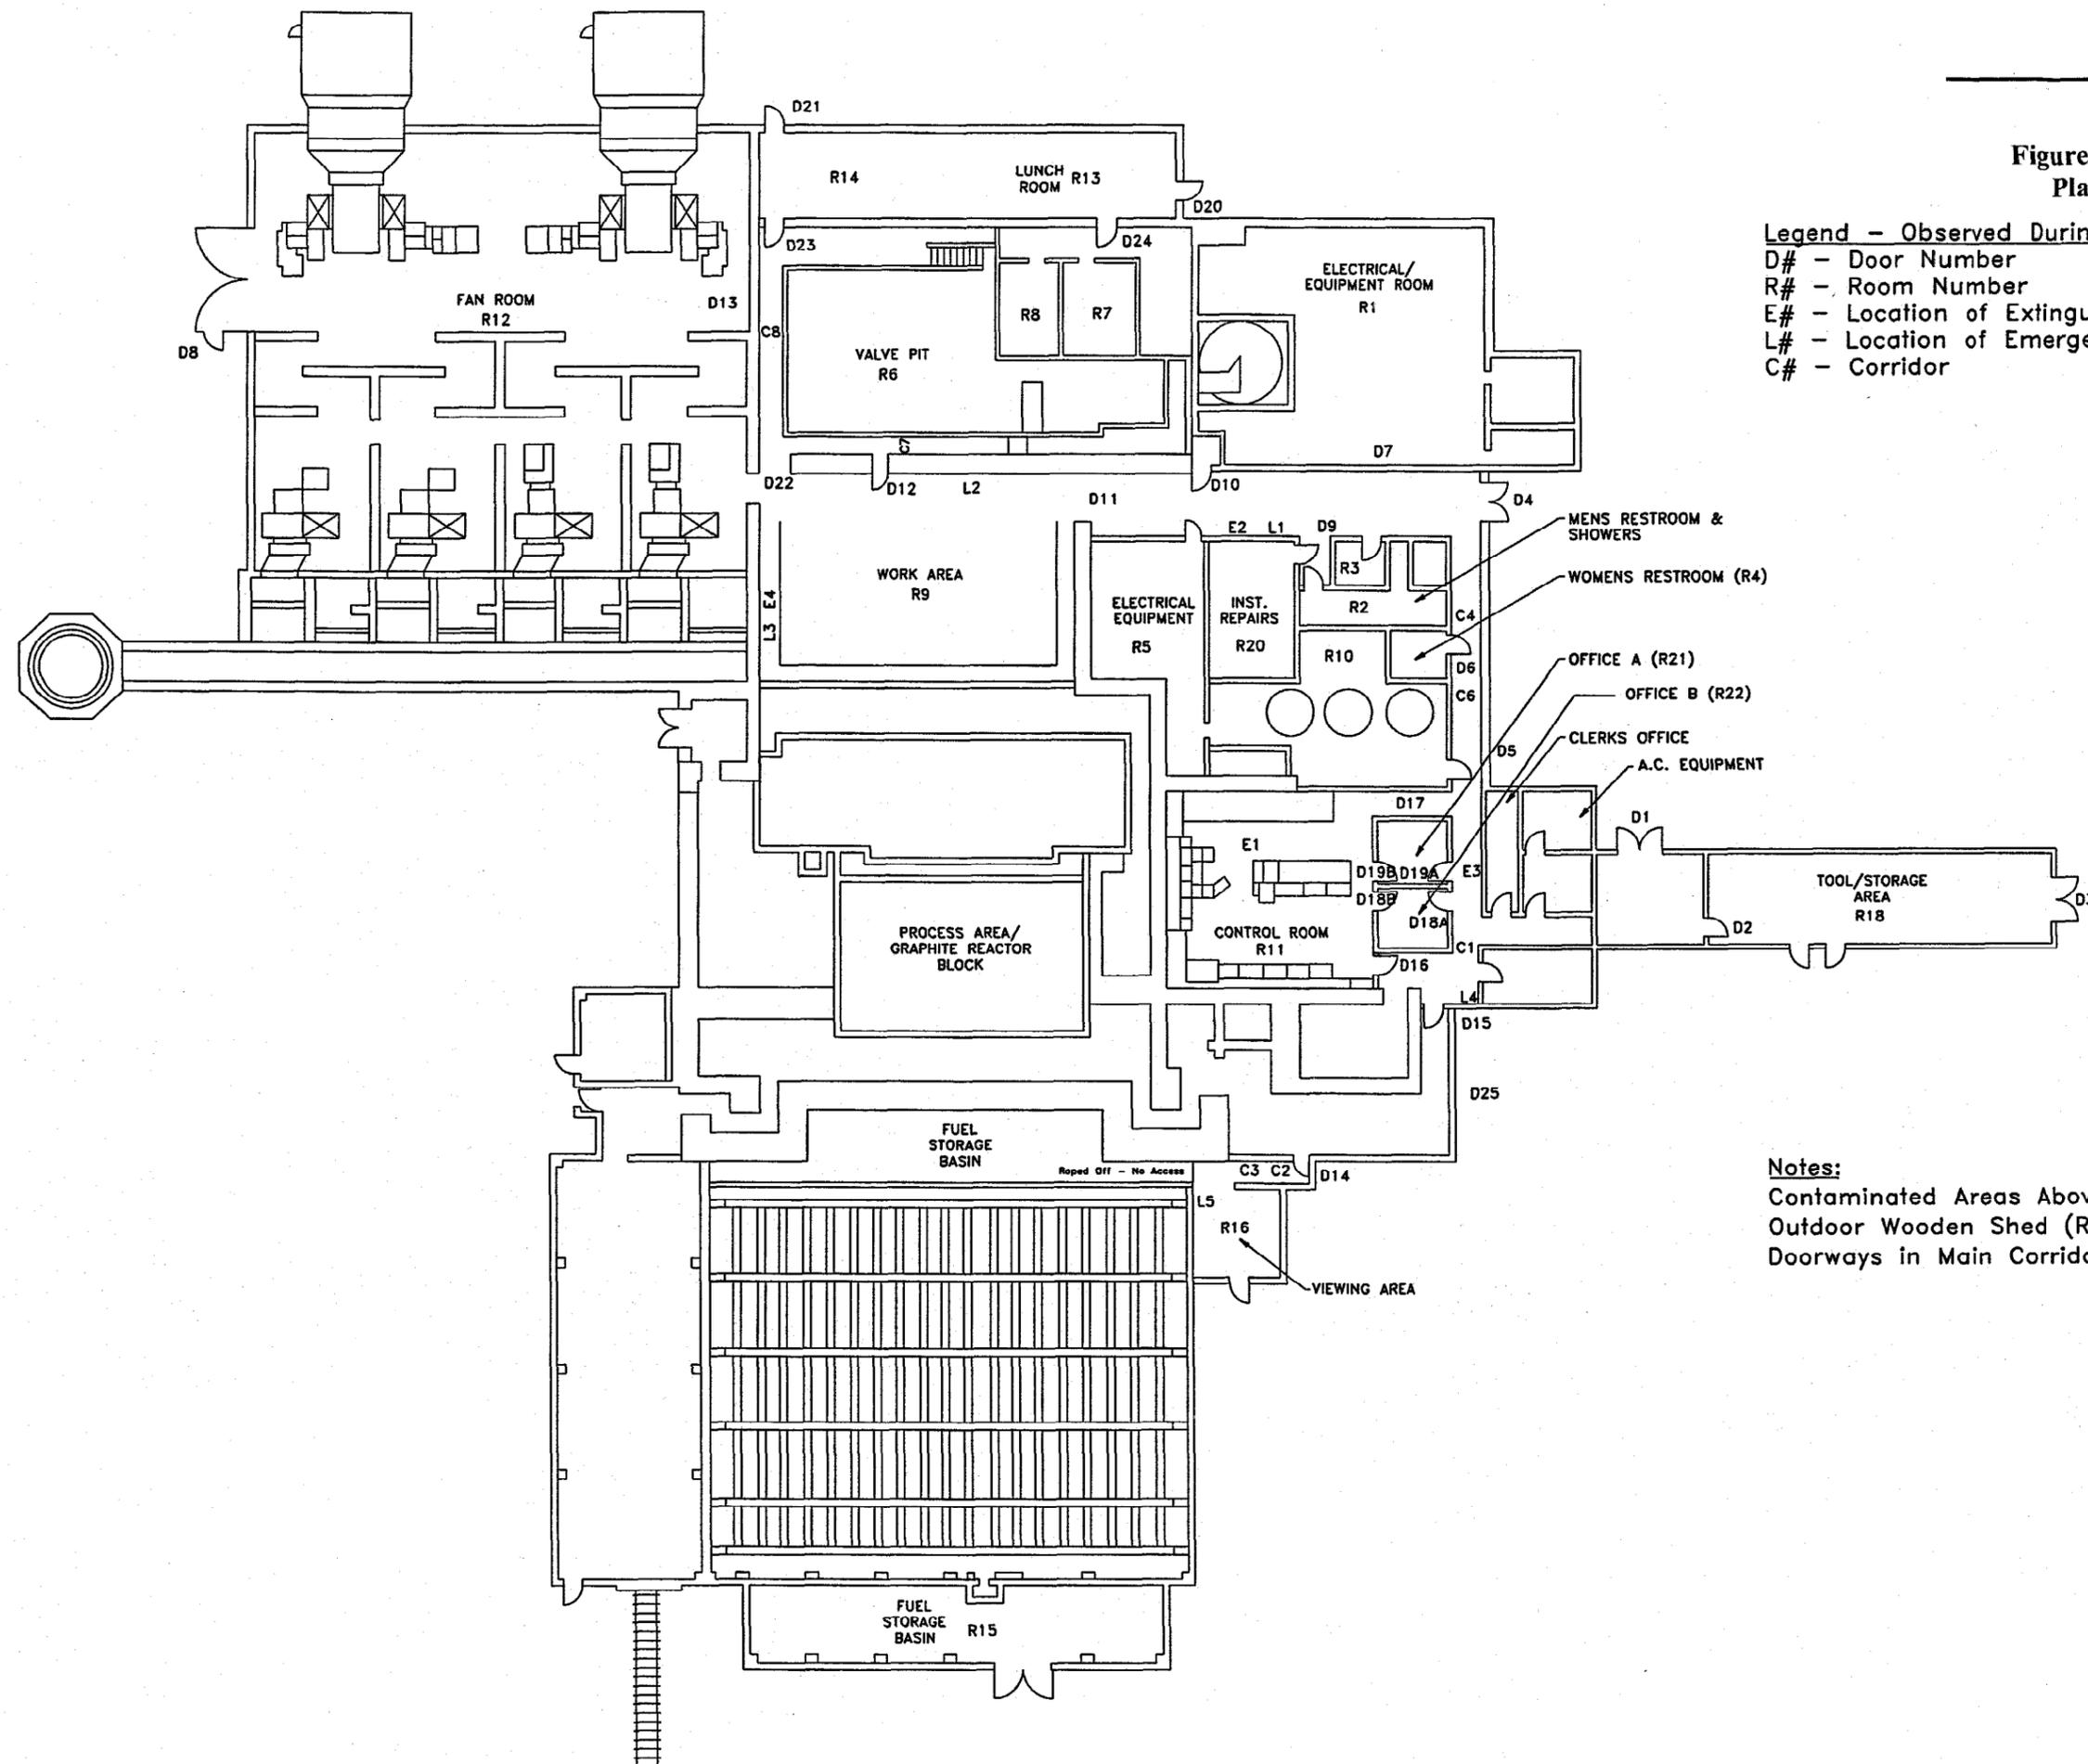
Figure C-1. 105-B Reactor Floor
Plan (Current Condition).

Notes:
Contaminated Areas Above Ground Level (R17)
Outdoor Wooden Shed (R19)
Doorways in Main Corridor (C6)
