BHI-01282
Rev. 0

Hanford B Reactor Building Hazard Assessment Report

Submitted by: Bechtel Hanford, Inc.

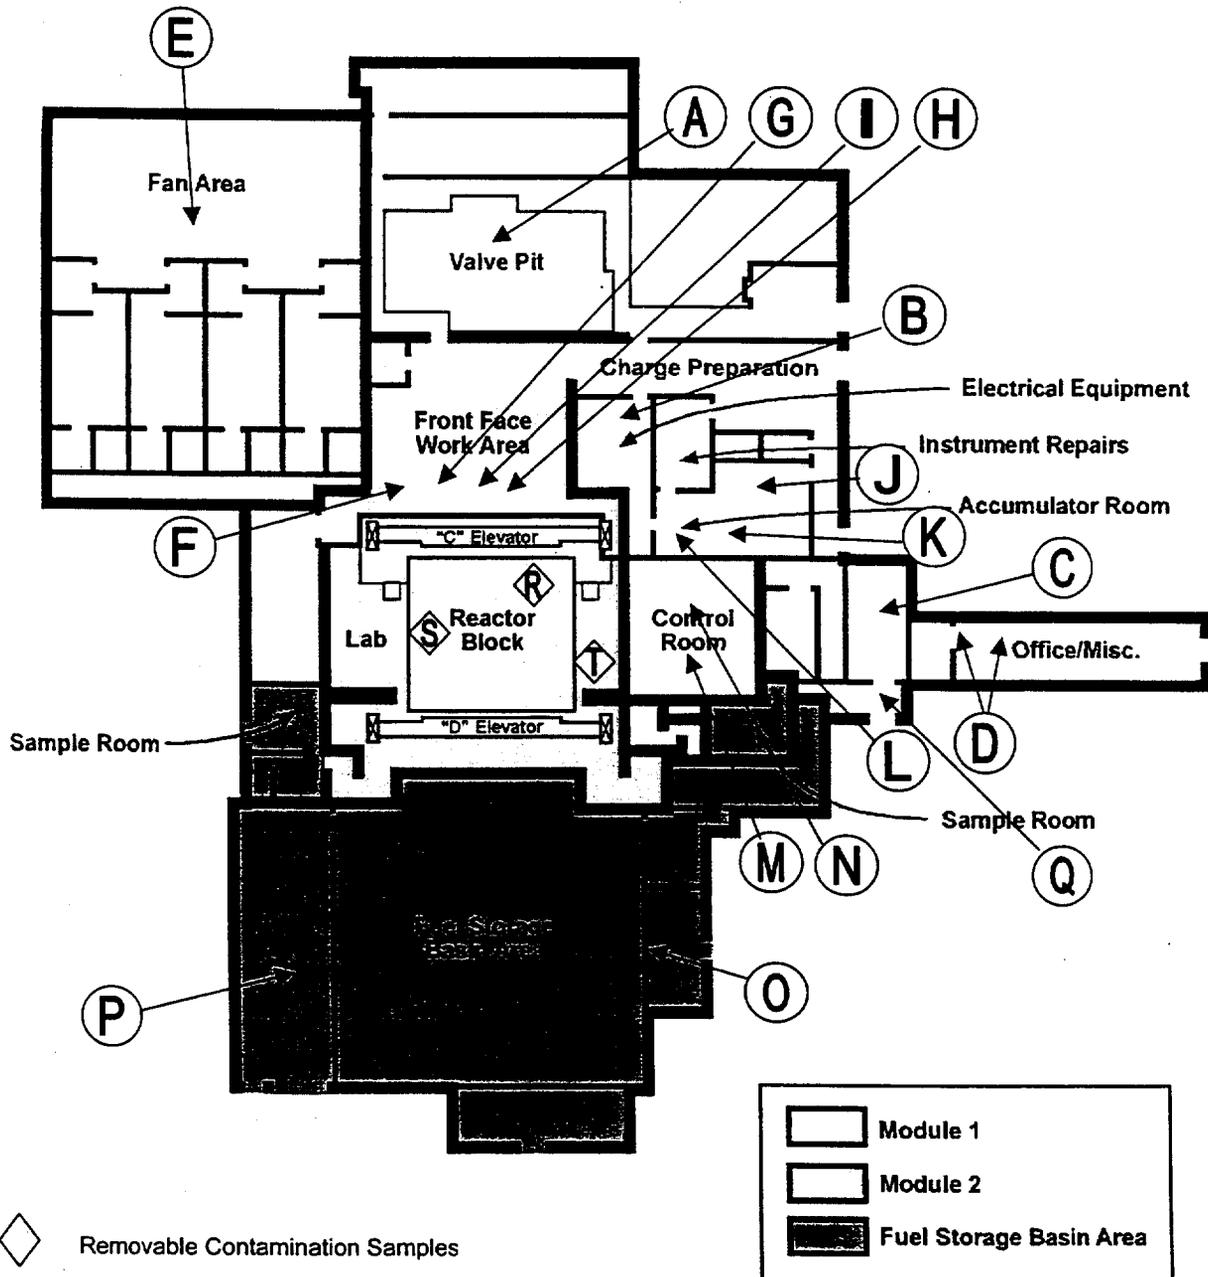
Plan View at Ground Level

FACILITY: 105-B Reactor	DATE: March 22, 1999	H.P. TECHNOLOGIST: K. D. Larson 3-1662
SURVEY INSTRUMENTS: Eberline E-600, S/N 1381 CALIBRATION DUE: 10-01-99	PROBE: N/A CALIBRATION DUE: N/A	BACKGROUND (BKG): 142 cpm
AREA SURVEYED	MAP LOCATOR ¹	MEASUREMENT (includes background) (CPM) ²
105-B REACTOR BUILDING - COUNT RATE MEASUREMENTS - USE COUNT RATE RESULTS LOCATOR		
Valve pit - ambient level	(A)	164
Switchgear Room 35	(B)	BKG
Portable HEPA equipment	(C)	BKG
Decon showers/locker room	(D)	BKG
Fan room - ambient	(E)	200
Pump "contaminated area" and fork lift	NL	250
Front face - ambient	(F)	500 - 550
Front face - floor	(G)	750 - 900
Front face - display (max reading)	(H)	450
Display table - boron balls	(I)	BKG
Buffer area - accumulator tanks	(J)	350 - 450
105-B REACTOR BUILDING - COUNT RATE MEASUREMENTS - USE COUNT RATE RESULTS LOCATOR		
Unlabeled door between Accumulator room and outer	NL	400 - 500
