BHI-01172
Rev. 3

Surplus Reactor Auditable Safety Analysis

*Prepared for the U.S. Department of Energy, Richland Operations Office
Office of Environmental Restoration*

Submitted by: Bechtel Hanford, Inc.

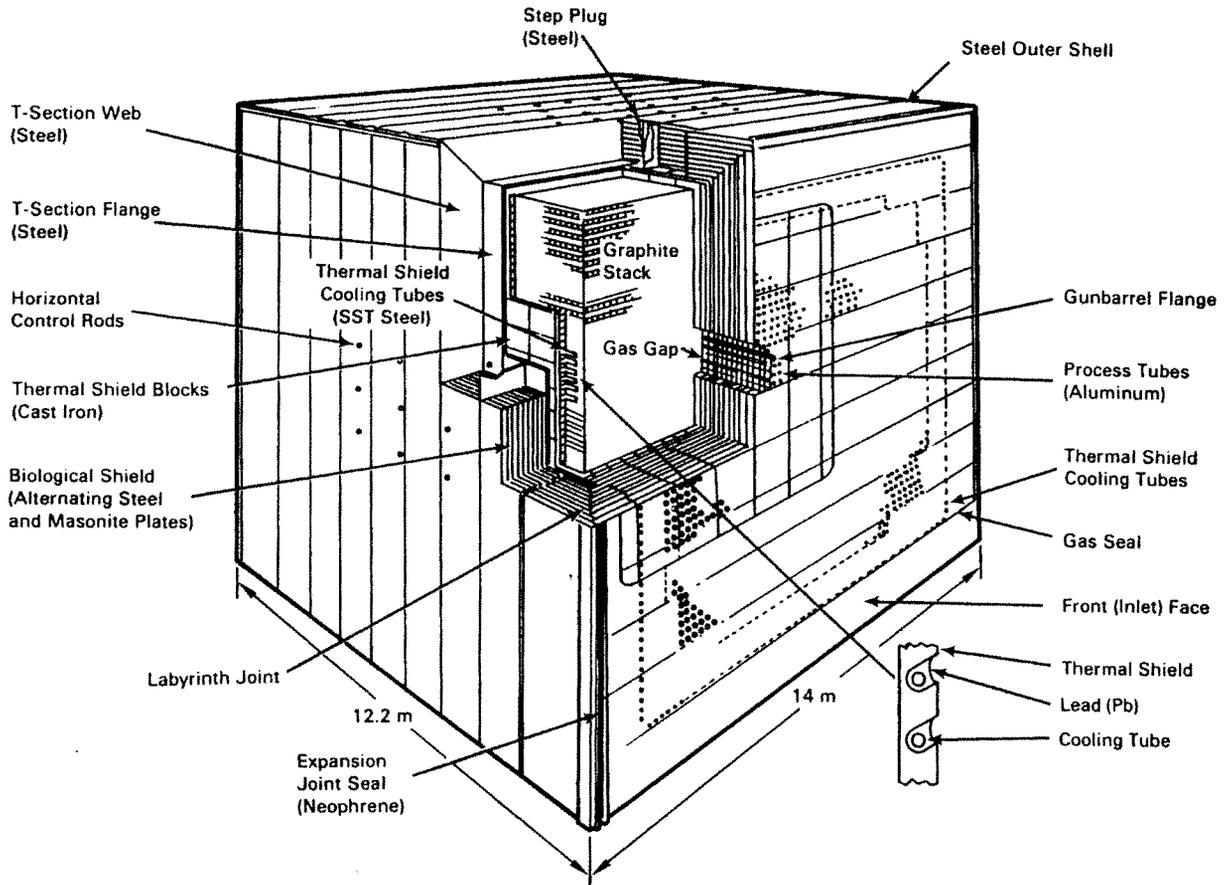
Figure 2-5. Reactor Block Construction (Typical).

105-KE and 105-KW Reactor Design Data	
• Graphite stack dimensions	33.5 ft x 41 ft x 41 ft
• Mass of reactor block	12,100 tons
• Number of process tubes	3,200

105-B, C, and F Reactor Design Data	
• Graphite stack dimensions	28 ft x 36 ft x 36 ft
• Mass of reactor block	8,930 tons
• Number of process tubes	2,004

NOTE: This figure is representative of the 105-KE and 105-KW Reactor blocks with the following exceptions: (1) biological shield constructed of heavy-aggregate concrete rather than steel/masonite laminate, (2) the size of K Reactor blocks are larger, and (3) the K Reactors had Zircaloy-2 process tubes in addition to aluminum.

Reactor block. The reactor block is located near the center of the building. The reactor block consists of a graphite moderator stack (36 ft high by 36 ft wide by 28 ft deep) encased in a cast iron thermal shield (8 to 10 in. thick) and a biological shield consisting of alternating layers of steel and Masonite[®] (52 in. thick). The entire block rests on a massive concrete foundation. The block weighs approximately 8,930 tons. Figure 2-5 shows the typical reactor block construction.

Reactor block. The reactor block is located near the center of the building. The reactor block consists of a graphite moderator stack (36 ft high by 36 ft wide by 28 ft deep) encased in a cast iron thermal shield (8 to 10 in. thick) and a biological shield consisting of alternating layers of steel and Masonite (52 in. thick). The entire block rests on a massive concrete foundation. The block weighs approximately 8,930 tons. Figure 2-5 shows the typical reactor block construction.
